# Shelter Bay Amenities Master Plan

Final Report

February 28, 2022

Project Consultant: Olsen Associates Architecture + Planning

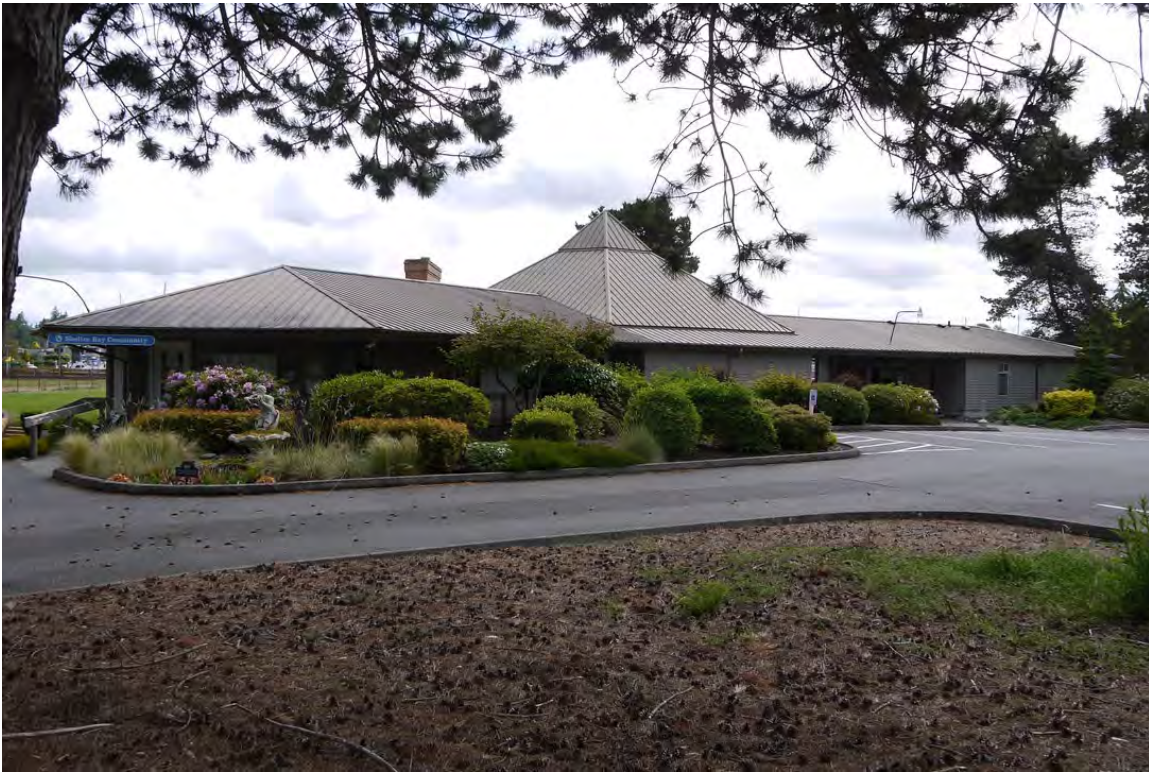
## Amenity #1 Clubhouse & Office

The Clubhouse is a fifty-year-old well-used multifunction building. It consists of the **Common Area** of 2400 SF area that includes a full kitchen and storage for chairs and tables. This hexagonal open space accommodates community meetings, parties, and gatherings for the members and the general public on a for-rent basis. The kitchen requires some upgrades, and there are requests for additional interior space to facilitate larger gatherings. The kitchen has had minor modifications, but equipment upgrades are necessary. An improved sound system has been added, but a slight echo remains. The recent addition of overhead video gives meetings added value and possibilities of a Shelter Bay Cinema and the now successful Shelter Bay Community University.

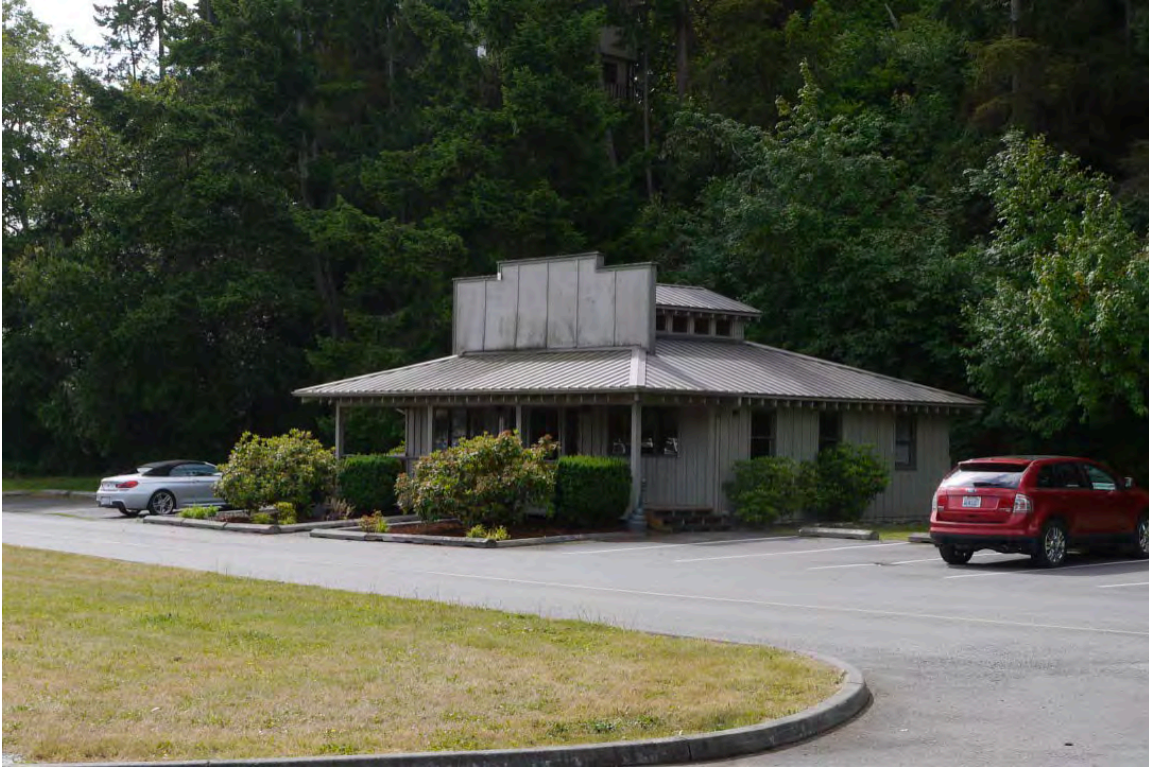
## Amenity #2      Annex Office & Library

The **Annex** is a temporary building constructed as the initial Shelter Bay Sales Office. It is a 948 SF wood-framed building divided into an entry library of 242 SF, a conference room of 220 SF, a 297 SF work area for two staff with a small conference table between the work areas. There is also an accounting office of 100 SF shared by two staff members. The Annex also serves as an overflow area for staff and meeting areas for Committee and Board members.

**It is recommended** that the Annex functions be considered as part of the Core Area Planning Study so that its relationship to the primary office functions can be investigated and resolved.

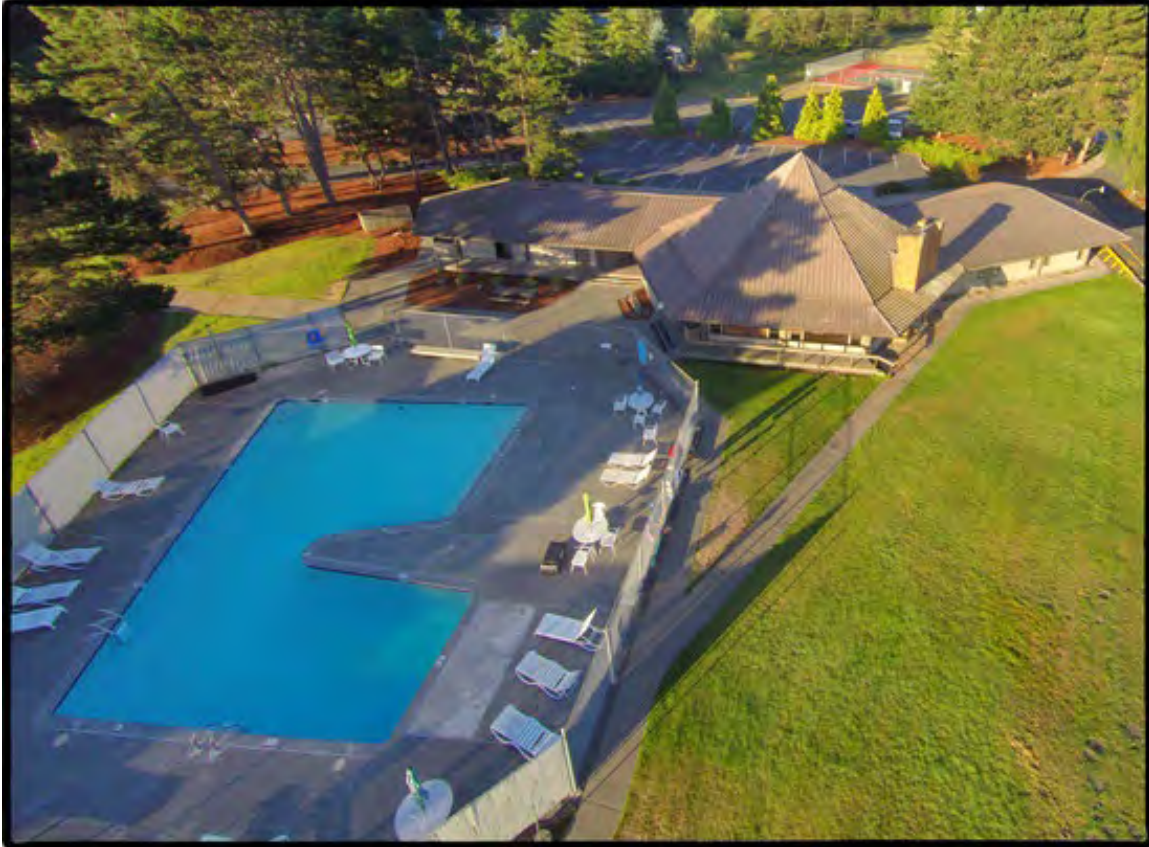
## Amenity #3 Clubhouse Pool

The fifty-year-old Clubhouse Pool is an outdoor leisure pool adjacent to the community clubhouse. The mechanical systems are housed in a small room within the clubhouse building. The pool is a single body of water with stair entry and water depths from approximately 3 feet to 8.5 feet, with an approximate water volume of 46,000 gallons. The Clubhouse Pool vessel is constructed with concrete and plaster finish lined with tile borders. The pool is filtered using a pressure diatomaceous earth (DE) filter. The pool is disinfected with solid chlorine tablets in an erosion feeder. The water pH is balanced manually using granular balance chemicals. Pool water heat is provided by a gas-fired heater on the exterior of the building.

**It is recommended** that the Board pursue an agreement with the SITC to extend the Temporary Operating Permit for one more year with the understanding that funding, design and construction of a new pool will begin in 2022.

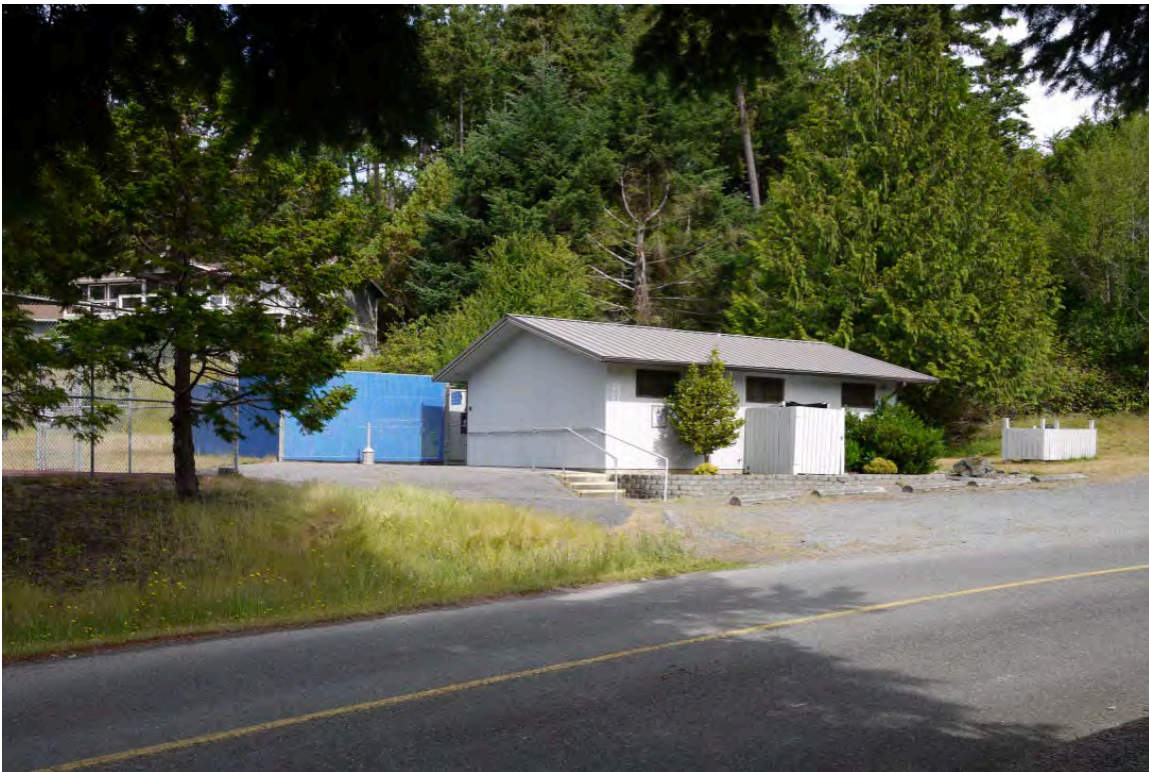
## Amenity #4 Upper Pool

The Upper Pool is an outdoor leisure pool adjacent to a community tennis court and basketball court. The Adult pool is approximately a half-mile from the Clubhouse Pool. The mechanical systems are housed in a bathhouse building adjacent to the pool. The pool is a single body of water accessed via portable stairs. The pool water depths are approximately 3 feet to 9 feet. The pool has an approximate water volume of 36,000 gallons. The pool was partially filled and not operational at the time of observation. The Upper Pool vessel is constructed with concrete and the interior finish is plaster with tile borders. The pool is filtered using a pressure diatomaceous earth (DE) filter. The pool is disinfected with solid chlorine tablets in an erosion feeder. The water pH is balanced manually using granular balance chemicals.

**It is recommended** that due to the extraordinary expense of renovating the Upper Pool, and with a view to the synergies available at the Clubhouse Pool site, the Upper Pool should be scheduled for demolition and removal, and that its functions be incorporated into planning, design and implementation of the Clubhouse Pool. Demolition of the Upper Pool is estimated at \$88,000.

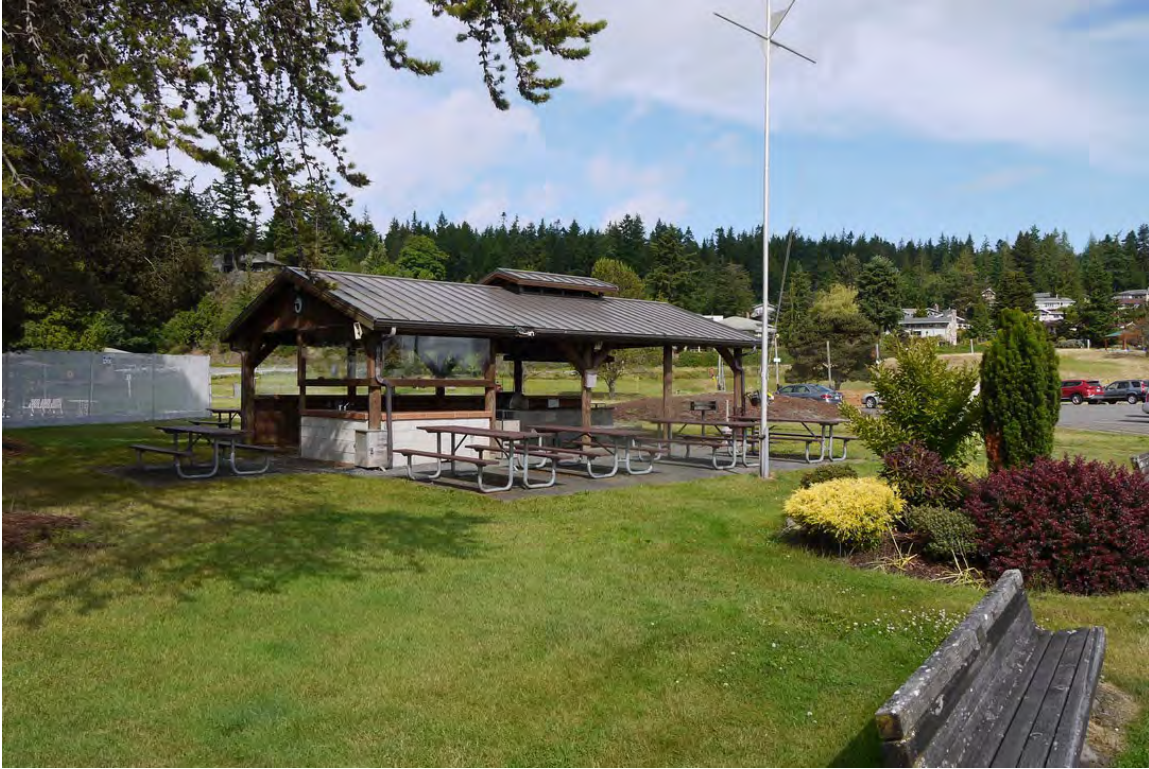
Amenity #5      BBQ Pavilion Area

A few yards north of the Clubhouse Pool, the **BBQ Pavilion** is a 20x32 foot open-air pole building for Shelter Bay member's usage or rental for outdoor functions. The facility consists of a kitchen area with a sink, cold water only, a BBQ gas grill, a fire grilling area for large events, or a small charcoal grill for individual activities. Ten movable exterior picnic tables and a few interior fixed seating areas enhance the BBQ Pavilion's purpose. The Budget Year 2020-21 set aside \$3,500 for a new gas grill, planned for installation in August 2021. In addition, requests have been made to supply hot water to the existing sink. After evaluating the electrical supply, it was determined there were no available circuits for an insta-heat system. However, if the current lights are changed to LED, we could reduce the wattage demand and create available circuits to accommodate the hot water unit. This should also reduce our electric bill. The 2021-22 budget added \$5,000 for upgrades to the BBQ Pavilion area. Repairs to the columns are completed. A preliminary cost estimate of the lighting change is approximately \$3,500-4,000.

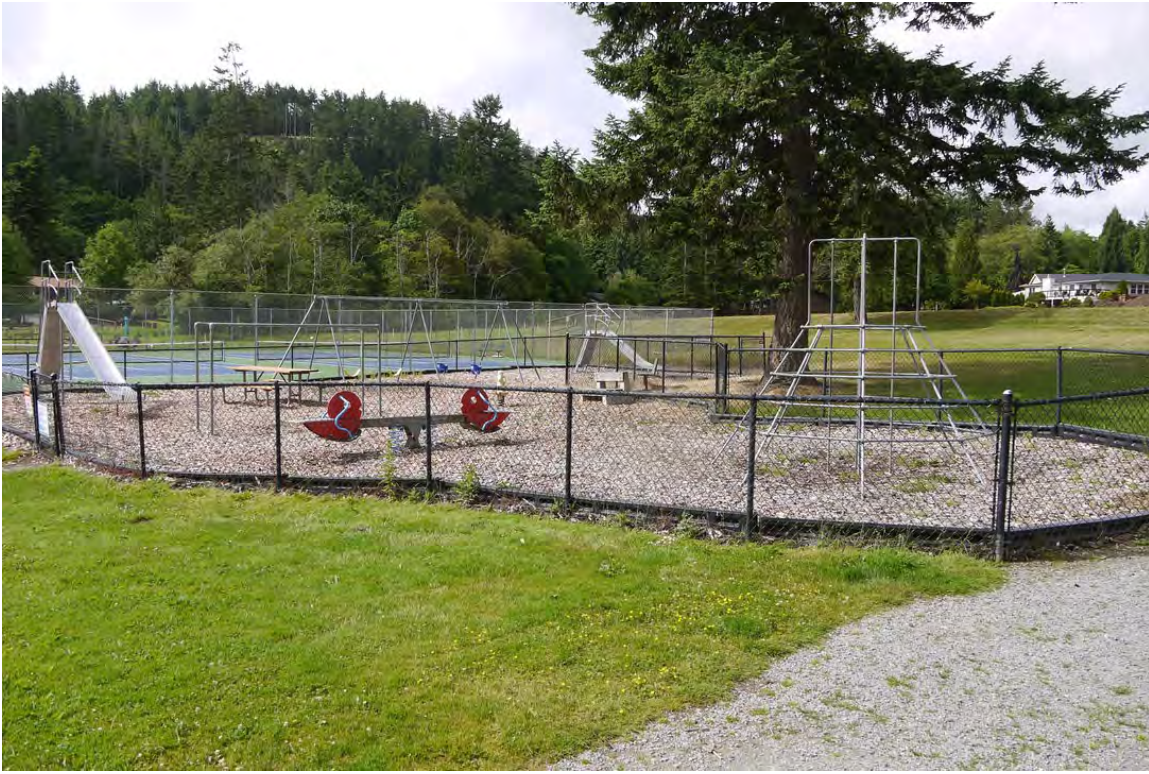
## Amenity #8 Playground

It is estimated that nearly 100 children who might use the playground live in Shelter Bay. In addition, seasonal visitors to grandparents can easily double the users of this facility. It is centrally located in the community, with several "adult" recreation facilities directly adjacent.

**It is recommended** that approximately \$40,000 be identified in the 2022 budget for design and installation of a children's play area of approximately 3,500 sf. to be located on the current playground site. The dog park and adult exercise facilities should be evaluated, budgeted and designed separately, as they may benefit from other locations within the community. Given other demands for open spaces, the current location of the playground within the core campus area and adjacent to other community facilities serves the needs of its users very well.

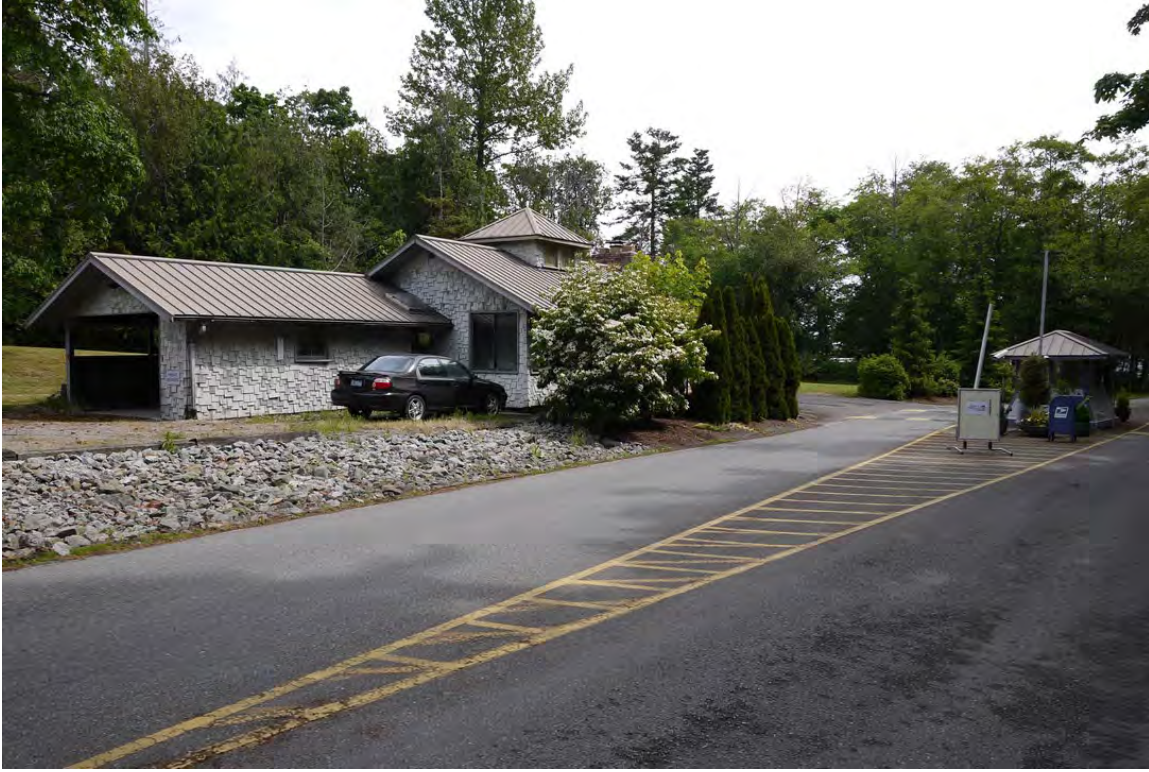
The Gatehouse is an approximate 450 SF house with living, kitchen, bath, and bedroom areas. Shelter Bay currently rents it out at \$ 800 per month. Unfortunately, the house is in need of substantial repairs.

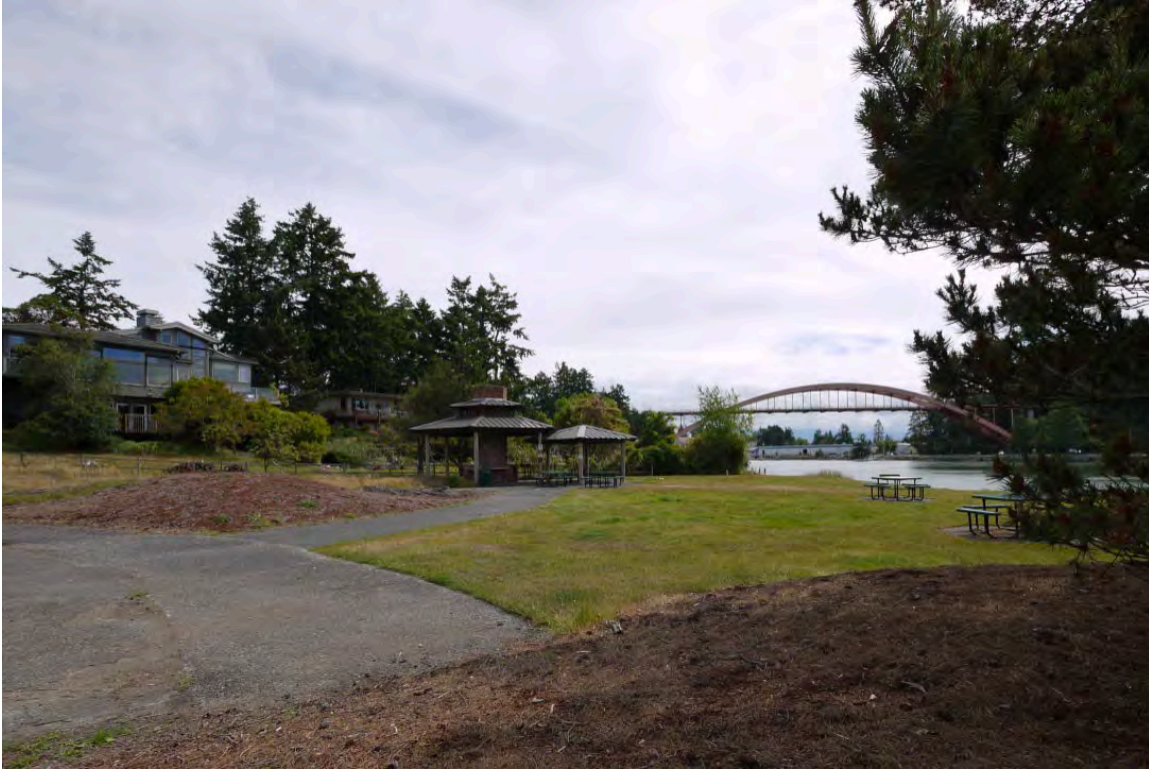
Rainbow Park is currently undergoing a major restoration to correct structural faults at the pavillions and to replace dying vegetation with new plantings. In addition, there is discussion with the Tribe regarding shoreline and bank stabilization to to erosion caused by wave action along the chanel.

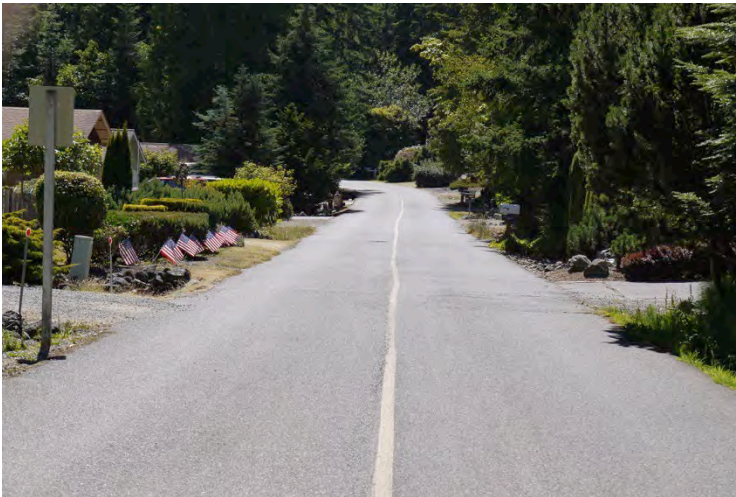
Narrow, dark, and residences have infringed rockery and vegetation at the edge of road, limiting pedestrian access. This trail should be studied to see if walkers and cars can share the road.

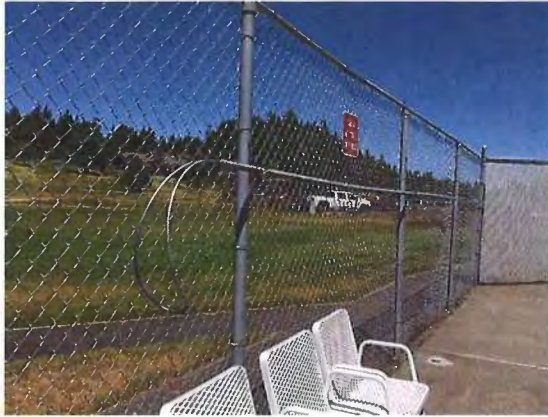
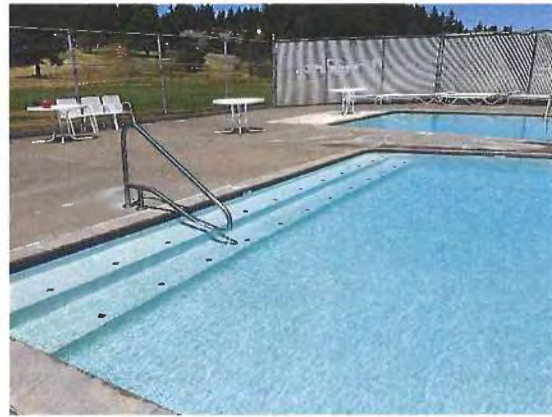
- Flowmeter is reading a low flow compared to size of pool. 48,000 gallon pool should have a 6 hour turnover rate. Putting the minimum flow rate at 134 Gallons Per Minute (GPM). The flowmeter was reading was approximately 120 gpm. However, Flowmeters are notoriously a bad indicator for actual flow. An issue that typically exist with flow meters are improper installation which appears to be the case for this pool. The use of a Pressure gauge and vacuum gauge on the pump in conjunction with the appropriate calculations and pump curve could give you a more accurate flow.
  - **WAC 246-260-041 (7)**

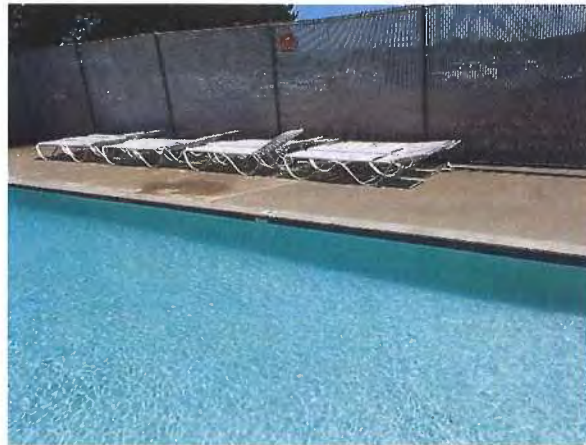
- Hand railings appear to be missing and steps are inconsistent in height which both pose a safety issue for those entering the pool. Should be evaluated by Certified Pool Building Professional.
  - **WAC 246-260-041 (11)**
- Additionally steps do not have a continuous line of contrasting color
  - It appears that this is not included in current code However, it will most likely be included in the next iteration of the code.

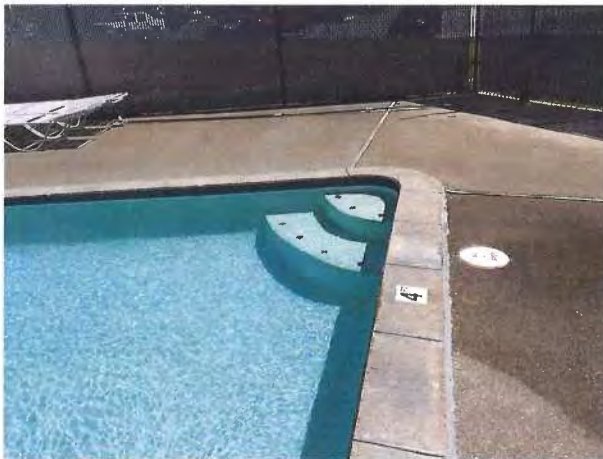
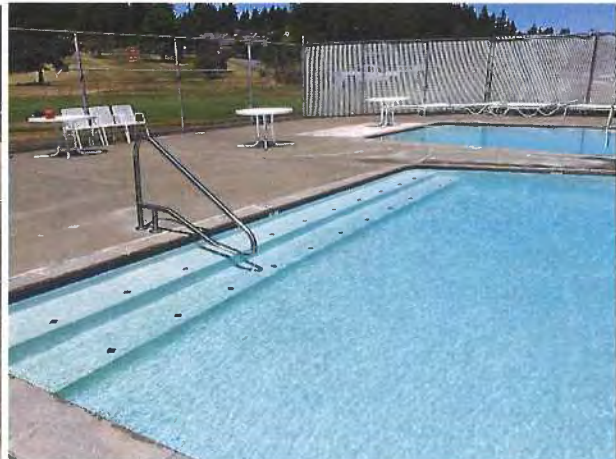
Skimmer furthest from the pump appears to have little to no flow through it. This can drastically affect appropriate circulation and disinfection of the pool. Additionally, all skimmers are missing Equalizer Lines to prevent air lock in the recirculation suction line. Should be evaluated by a Certified Pool Building Professional.

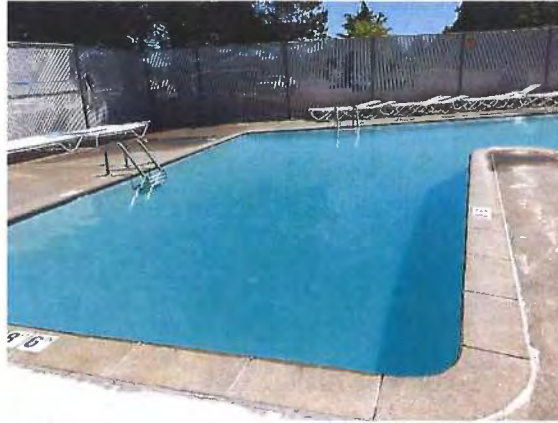
- Emergency Telephone is not provided. However, Office phone could be used if pool hours are the same as office hours.
  - **WAC 246-260-041 (11)**
- Ring Buoy was missing from enclosure. Ensure Ring Buoy with rope length the maximum width of the pool and Shepard's crook are available at all times within the enclosure.

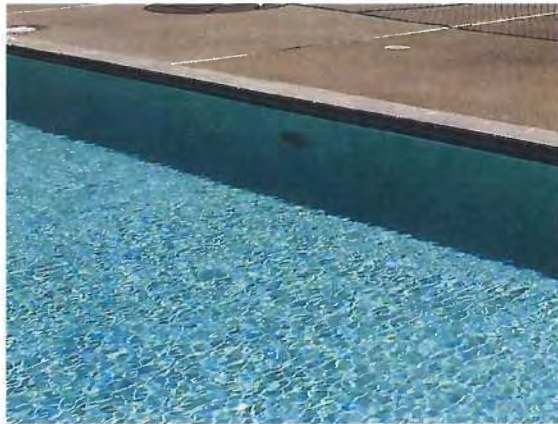
- Cyanuric Acid levels are high. Recommend draining pool to decrease levels or use product to decrease chlorine.
  - **WAC 246-260-121 (3)(iv)**

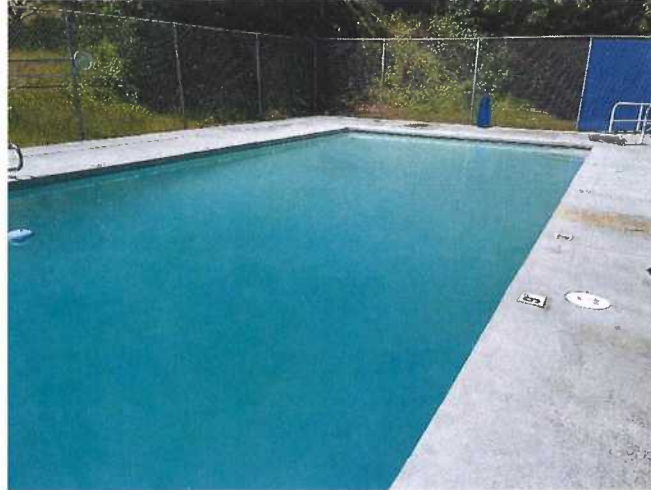
- Emergency Telephone is not provided. Provide
  - **WAC 246-260-041 (11)**
- All skimmers are missing Equalizer Lines to prevent air lock in the recirculation suction line. Should be evaluated by a Certified Pool Building Professional.
  - **WAC 246-260-031 (8)**
- Ring Buoy and shepard's crook missing from enclosure. Ensure Ring Buoy with rope length the maximum width of the pool and Shepard's crook are available at all times within the enclosure.
  - **WAC 246-260-041 (11)(g)**
- Floating weirs inside skimmers are missing. It is recommended these all be re-installed to ensure that debris in pool does not return to pool once it enters skimmer basket.
  - **WAC 246-260-031 (8)**
  - **WAC 246-260-111 (4)**
- Significant amount of debris was floating in pool: Clean.
  - **WAC 246-260-111 (4)**

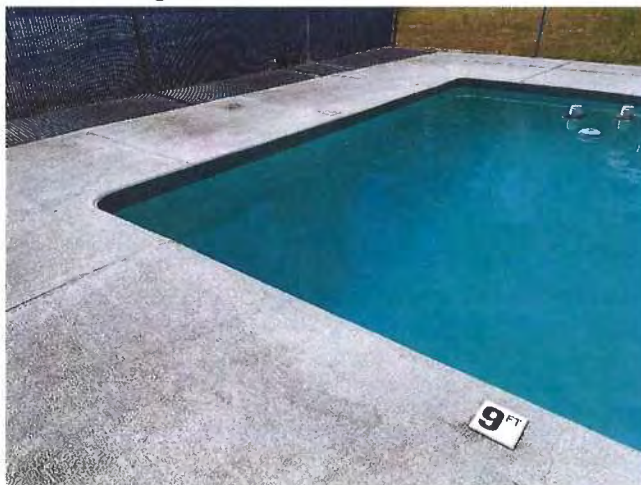
- Decking and coping is chipped and dirty: Repair/Resurface
  - **WAC 246-260-031 (8)**

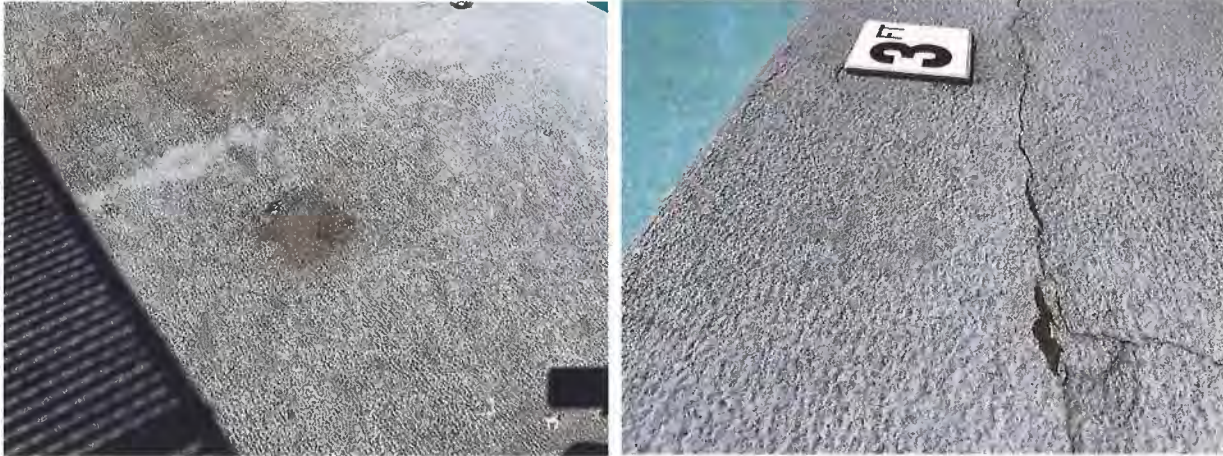
- Plaster is chipped and pitted and tile Line has broken and chipped tile. Repair/Replace
  - **WAC Chapter 246-260-041 (3)(a)**
- On deck depth markers provide tripping hazard. Replace.
  - **WAC 246-260-031 (8)**
