# Shelter Bay Amenities Master Plan

Final Report

February 28, 2022

Project Consultant: Olsen Associates Architecture + Planning

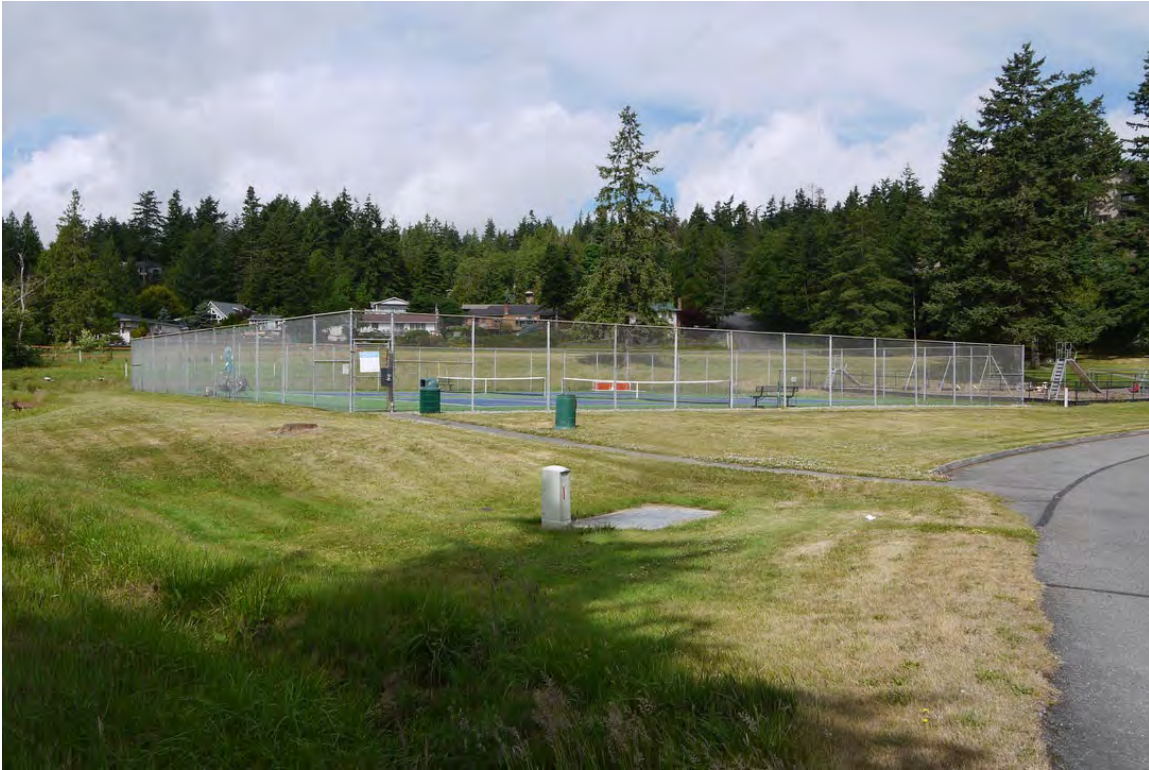
## Amenity #6 Clubhouse Tennis

The fifty-year-old Clubhouse Tennis Courts were repaired and resurfaced two years ago at the cost of \$35,000. The contractor recommends resurfacing the courts every ten years. The ten-year resurfacing may not require the crack repair performed during the summer of 2019. Therefore the ten-year resurfacing would cost approximately \$20-25,000. Cleaning the courts once a year costs \$1,000. The use of the courts is popular with Pickleball Athletes as well as pure-tennis buffs.

At this time no additional expenditures are proposed for this facility. However, to reduce future repair costs, a rigorous maintenance program should be followed.

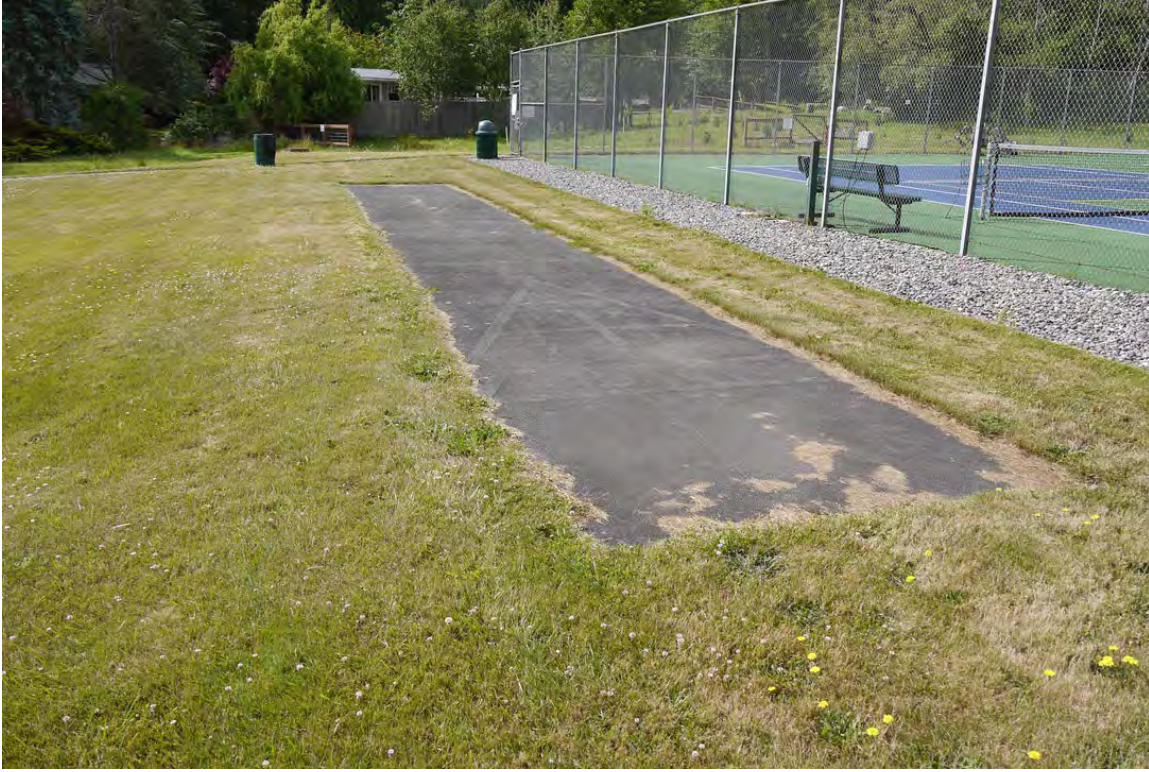
## Amenity #7 Shuffleboard

The shuffleboard slab of 6 x 52 ft. remains in place with faded paint demarcation. There appears to be a current lack of appeal in Shuffleboard. However, if interest arises again, paint can be applied, and equipment acquired at less than a thousand dollars.

No work is planned at this time.

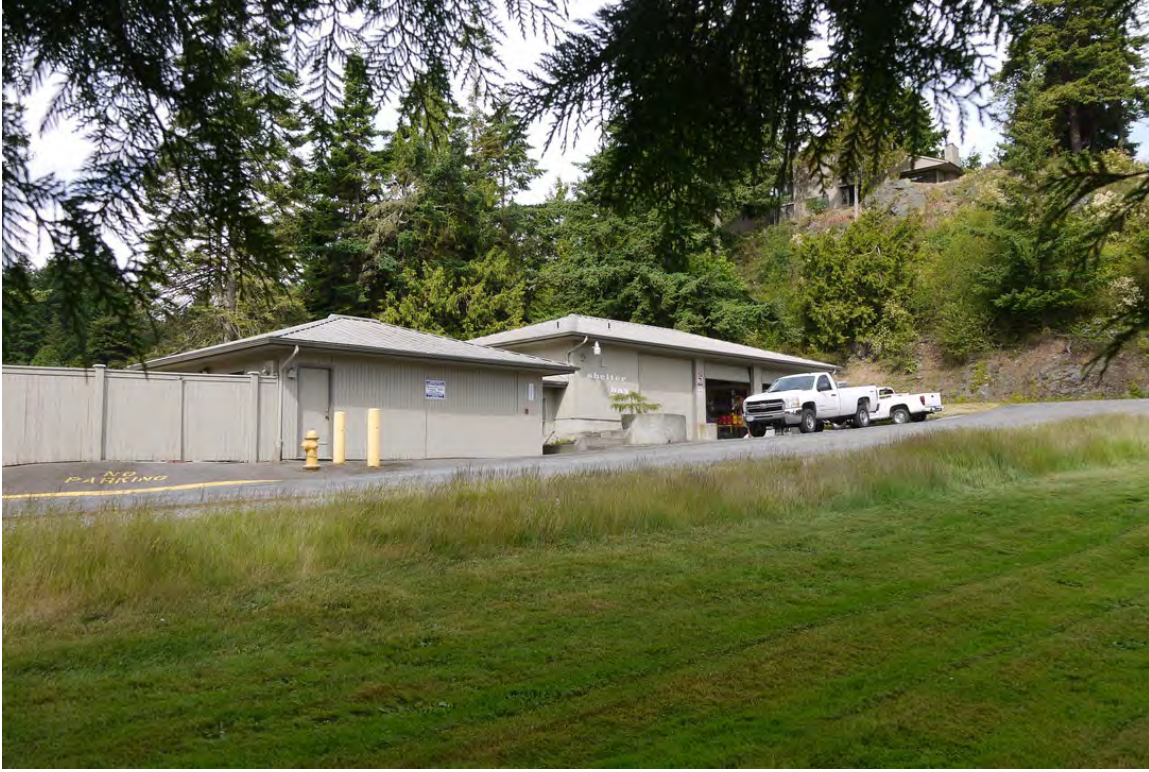
## Amenity #9 PW Building

This building is used primarily by the five-person Maintenance Department. The building is in good repair, and meets the needs of its users.

No major work required at this time. Only usual general maintenance is needed.

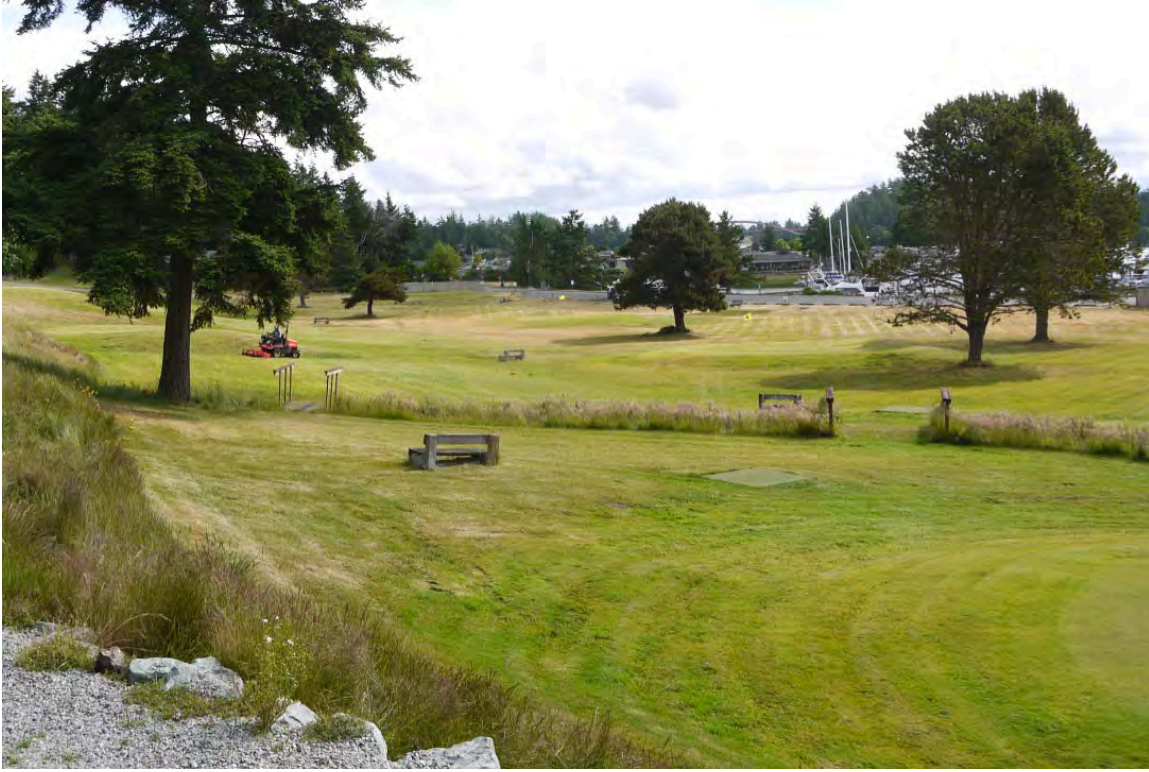
## Amenity #11 Golf Course

Shelter Bay's five-acre, nine-hole Chip-and-Putt Golf Course is small but challenging with its rough fairways, elevation variations, and a few water and tree obstacles to make it interesting until you get to the greens. As we all know, the short game is where one wins or loses, and here is the ideal area to practice with friends or grandchild. In the winter of 2020, several large trees were lost in a storm, and we need to plan how to reconfigure the course with new challenges.

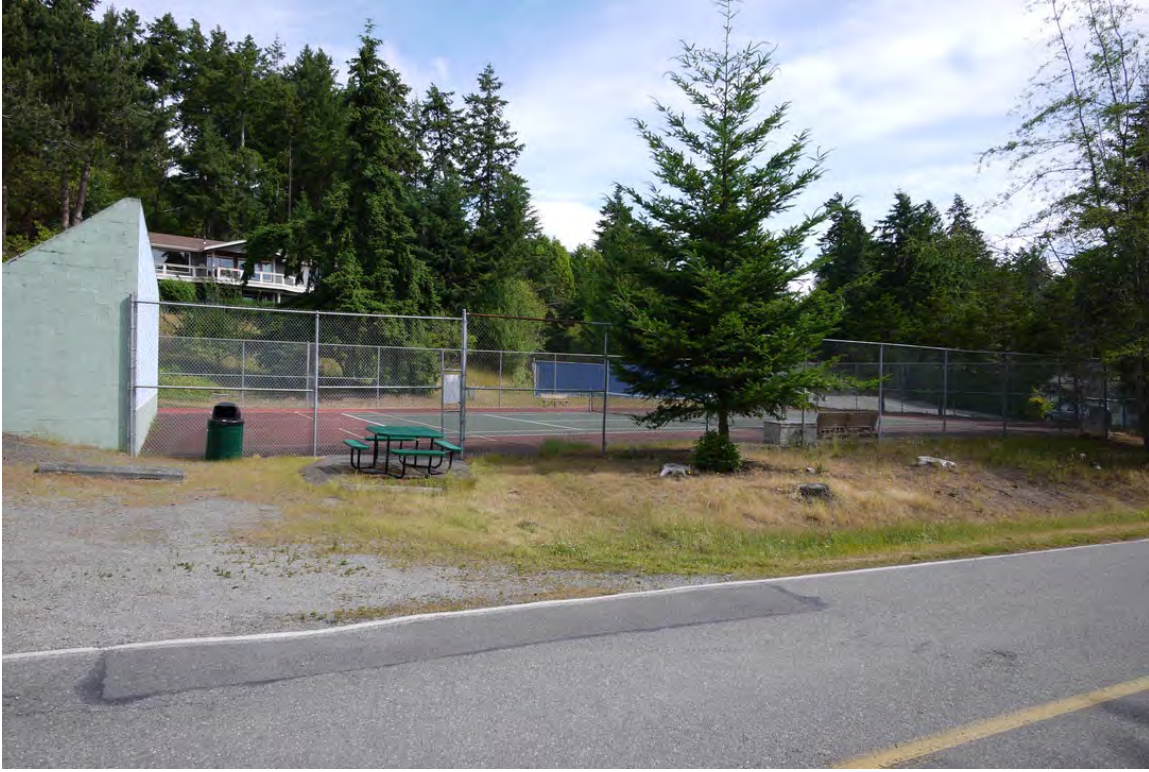
## Amenity #16 Upper Tennis

The Upper Tennis Court at the corner of Shelter Bay Dr and Coquille Way is in playable condition with a cosmetic need of resurfacing. Besides tennis and pickleball players, the court area is visited by exercise groups, children learning to ride their bikes, or parents wanting a safe place for their children to run and play within a controlled area. A tennis practice area is its primary use.

The cost to resurface is \$16-18K and \$500 a year to maintain. A sports consultant advised that without resurfacing, the court will not be functional within a few years. Currently, its condition gives the sense of neglect that could transfer to the whole community on how it is being kept. Therefore, making an indirect effect on the value of the member's personal property.

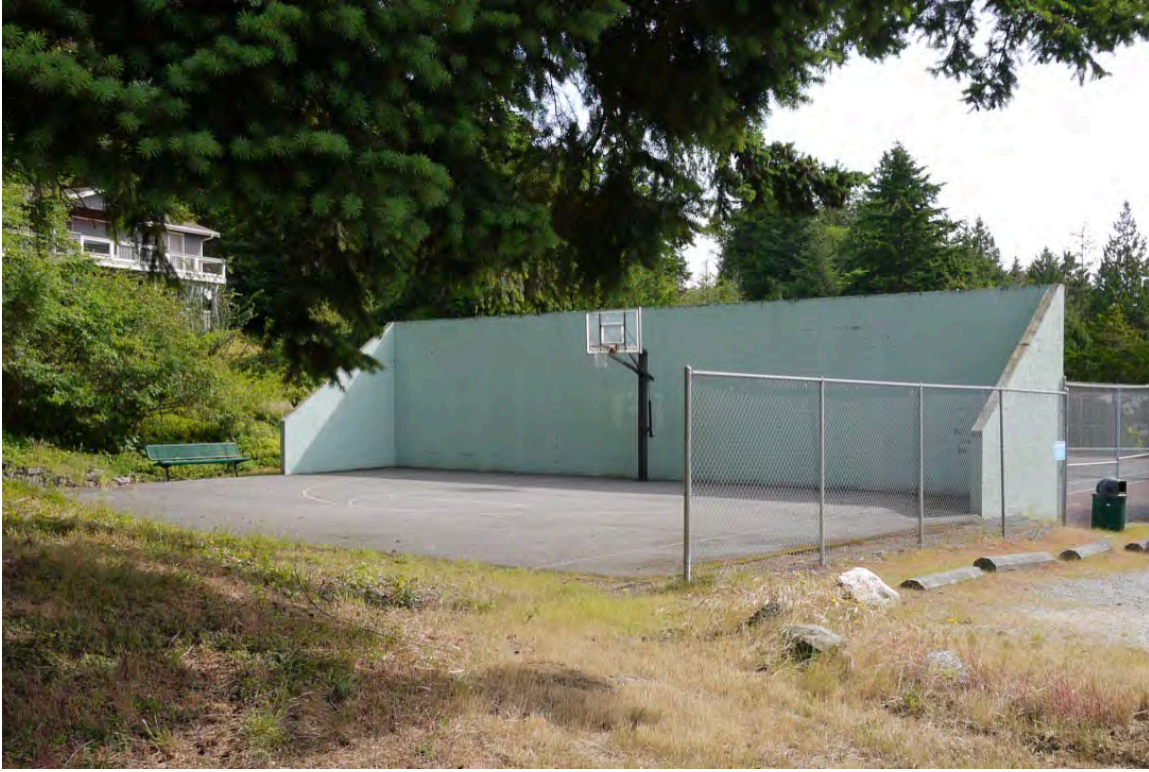
## Amenity #17 Basketball Court

Originally built as a handball court, then converted into a basketball court adjacent to the tennis court is frequented by teenagers. As resurfacing the tennis court would make it look kept, so too would the basketball court. The cost to resurface is approximate \$5-10K, depending on the extent and detail we wish to present.

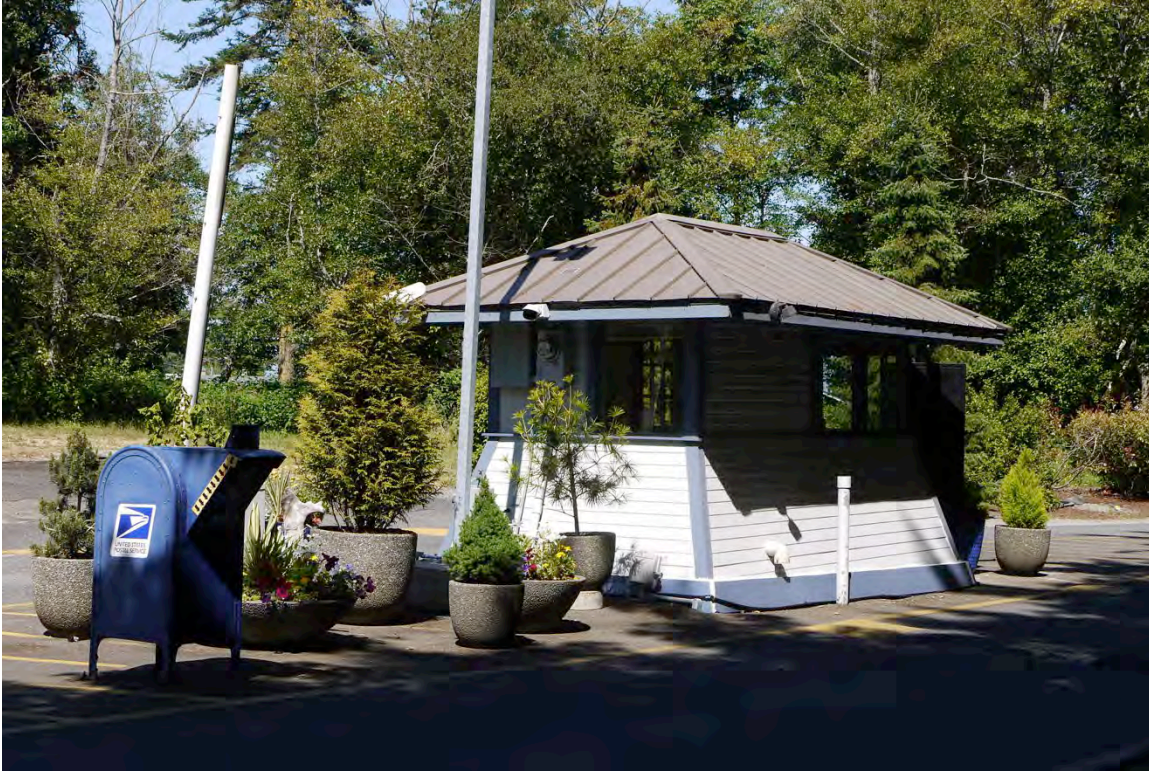
## Amenity #19 Guardhouse

Guards have been eliminated from the Shelter Bay Entrance, and discussion is heavily considering if a Guardhouse is necessary or the right look that Shelter Bay wants to present to our members, the Tribe, or La Conner area in general.

The building itself requires substantial repair, but it houses the security systems of the Storage Lot and the Entrance to Shelter Bay.

The Guardhouse no longer functions to serve as a shelter for gate attendants. There is on-going discussion as to whether this building is needed for the future of Shelter Bay, and whether a Guardhouse presents the desired image of Shelter Bay to our neighbors and visitors. The building requires significant repairs estimated at \$10,000 to \$15,000 if it is to remain. It is recommended that the building be removed and replaced with a welcoming and appealing entry planter that can serve as a traffic island and signage location while representing Shelter Bay as a garden community. Security and IT assets could be moved to the Gatehouse Rental. Estimated Cost is \$15,000.

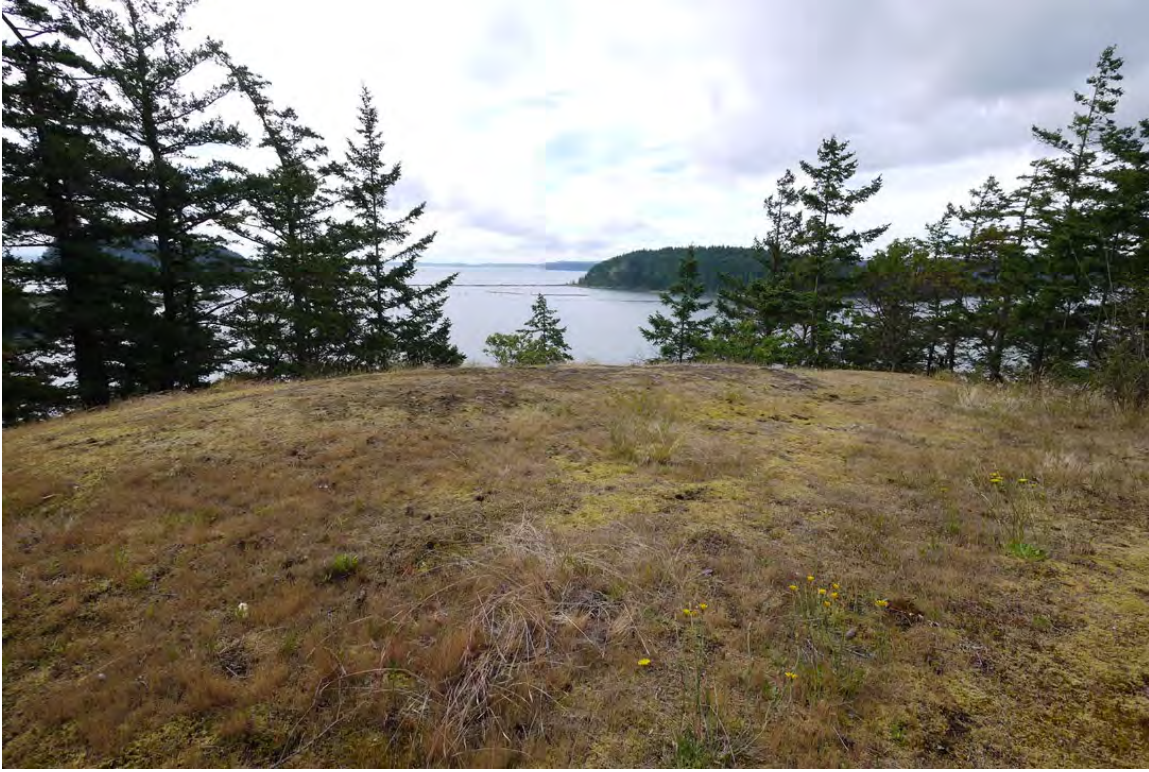
## Park P4 View Park

At 175 feet above sea level with views to the south as far as Mount Rainier, View Park is well named. Currently, there is a rudimentary trail to the top. Once the destination is reached, there is no bench to use to enjoy the view, no trash container or sign explaining the islands and channels laying out before the viewer.

Access from the base of this hill connects to Cliff Trail to Martha's Beach. Access from Siletz Place is steep and difficult, with no developed stairs, pathway or hand rails. Additional access could be developed to Tillamuk Drive.

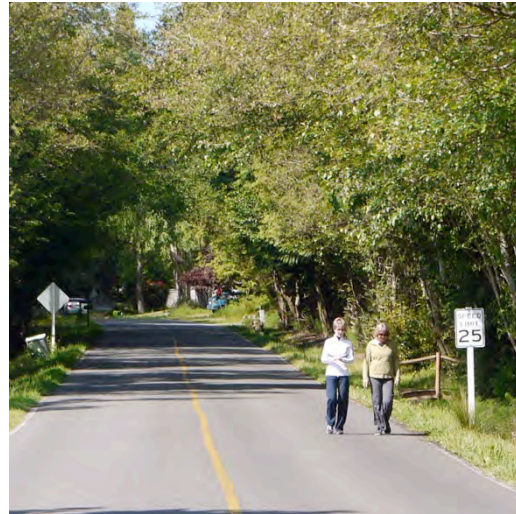
## Trail T 3 Klamath - Wasco Place

Currently, walkers using this 1/2 mile trail transition in and out from sun to shade, causing a situation where the walkers can't be seen promptly even at 15-20mph. The Posted speed limit 25. This is a well used pathway connecting upper and lower Shelter Bay Drive communities.

Study is needed to resolve this safety issue, and to define a path that allows for safe walking while co-ordinating well with drainage swales along the road edges.

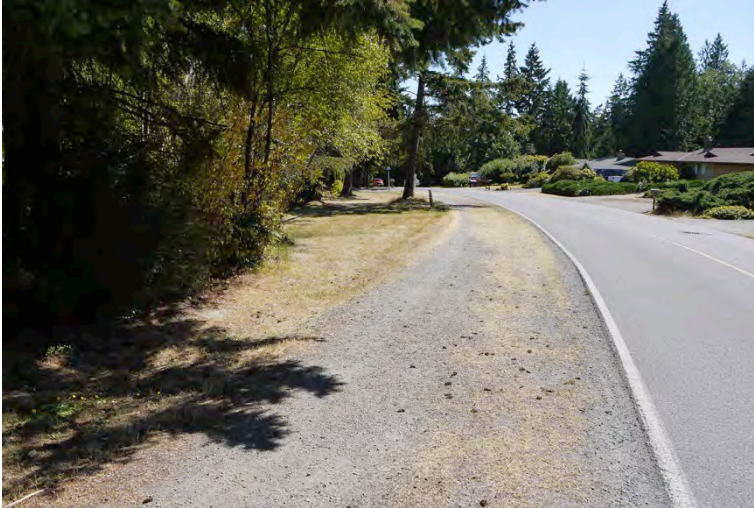
## Trail T 4 Golf to Guardhouse

This .86 mile stretch of trail connects the gatehouse with the Golf Course. It is heavily used by walkers from all neighborhoods in Shelter Bay. It has maintenance needs along most of its length, although recently a portion of it was re-surfaced as part of an infrastructure repair.

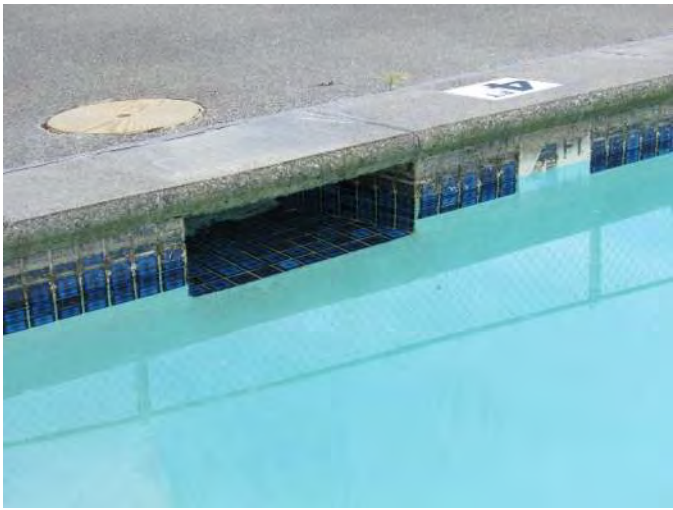
Image 04

Skimmer openings do not contain weirs  
(Image 04)

Several depth markers are not easily readable due to dirt/grime buildup and partial wear/deterioration of the label. (Image 04 & 11)

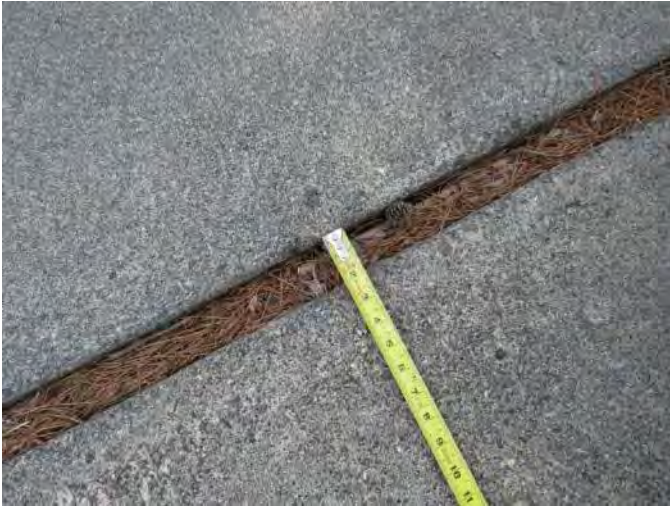
Image 02

Pool deck has large gaps and/or recessed joints larger than ½ inch; some found to be approximately 2 inches wide.  
(Image 02)

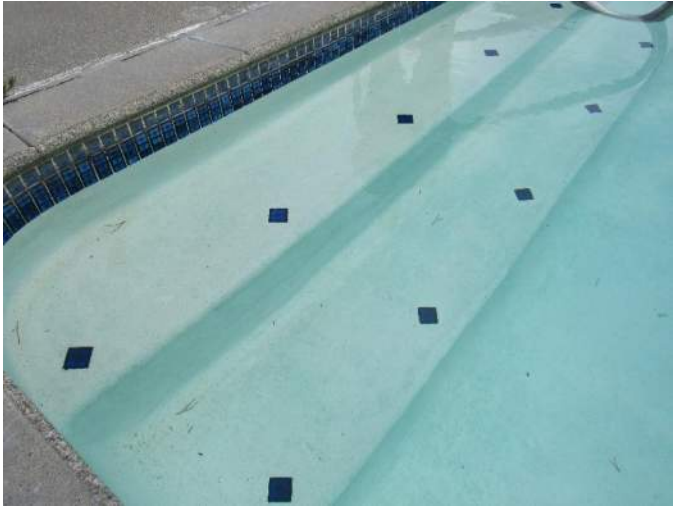
Image 05

Steps have periodically spaced “diamond” tile markers; unlikely to be considered sufficient markers of the edge of the step (Image 05)

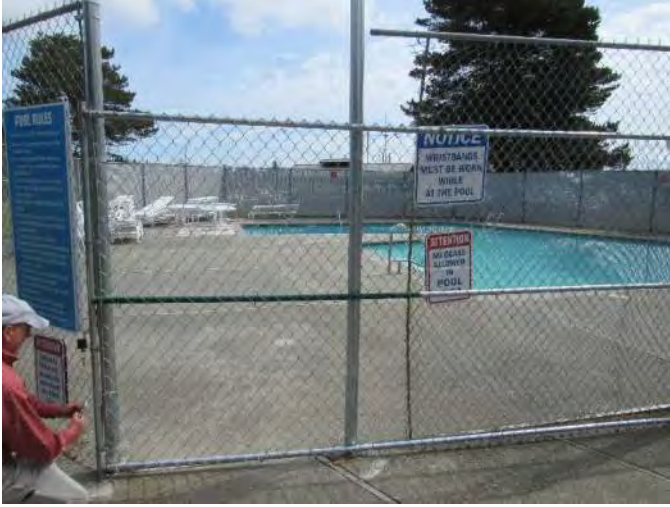
Image 03

Barrier gate is not self-closing, self-latching (gate had been damaged and is under repair at the time of observation)  
(Image 03)

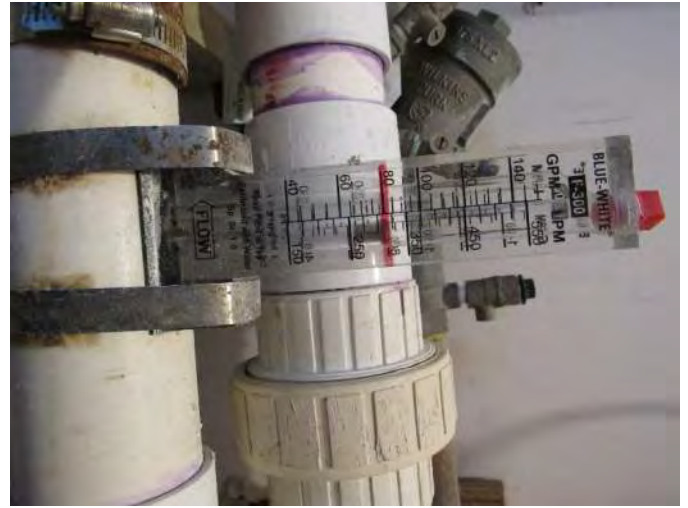
Image 10

At the time of observation, the installed flowmeter indicated a flow rate of approximately 80 GPM. At the report pool volume of 46,000 Gallons, this indicates a turnover rate of approximately 9.5 hours (Image 10)

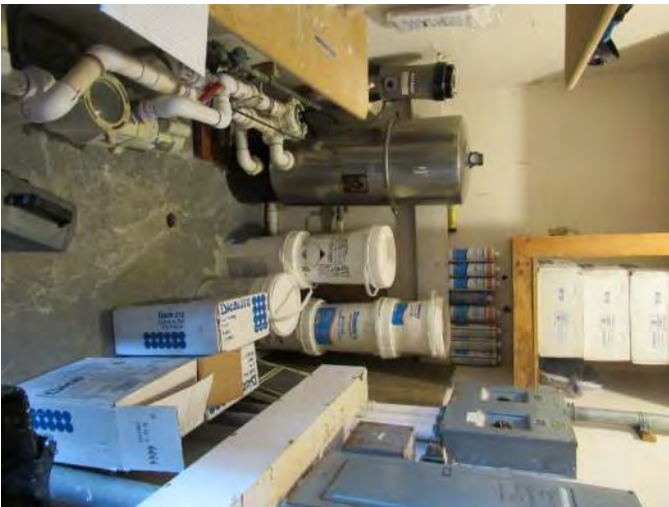
Image 09

Pool chemicals are stored adjacent to pool mechanical equipment. Room not sufficiently vented for chemicals. (Image 09)

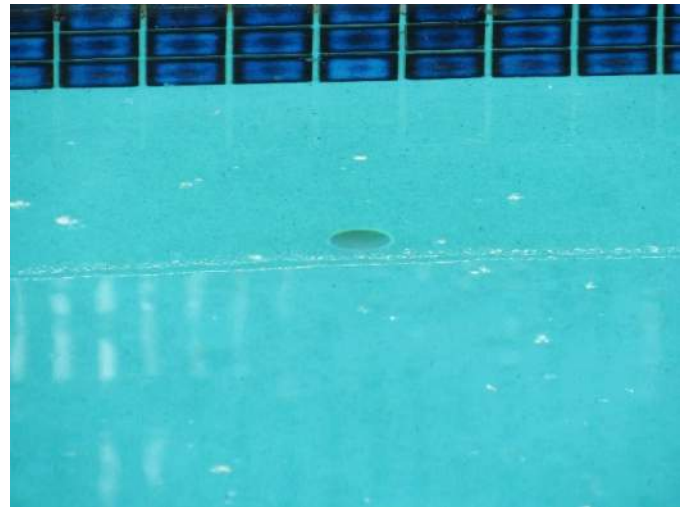
Image 12

- Several of the existing returns/inlets to the pool are stubbed pipes with no fittings in the pool. (Image 12) Stubbed pipes are not able to control the direction of the water stream into the pool. Standard “eyeball” directional return fittings can point the stream of filtered water and are useful in adjusting the flow to avoid disturbance of the water surface. Directional return fittings should be installed on all return/inlet pipes.

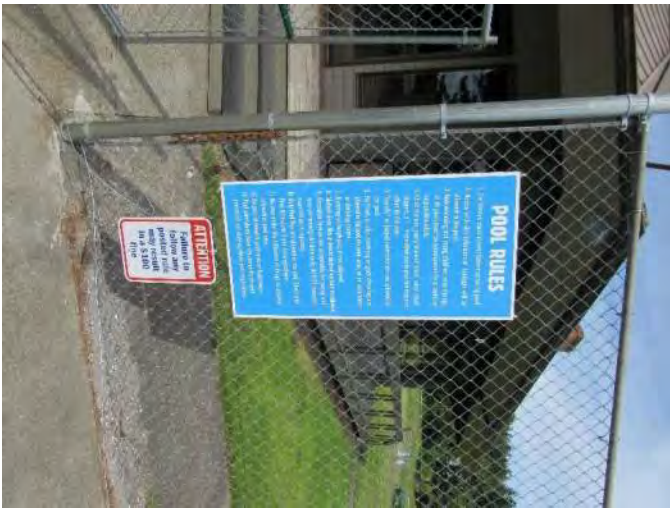
Image 13

Not stated in posted Pool Rules (Image 13)

Existing signage states “children under the age of 10 years” (Image 13)

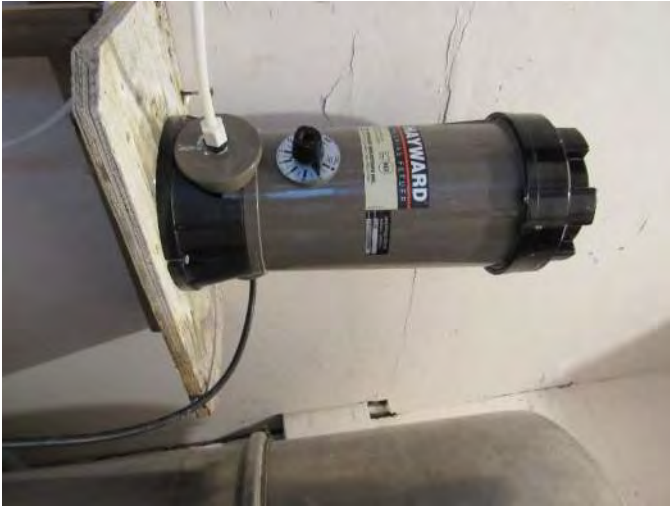
Image 14

- 1) All Recommendations from Level One
- 2) Install an Automated Water Treatment System
  - The current primary disinfection system mixes trichloroisocyanuric acid tablets (Trichlor) with pool water in an erosion feeder on a bypass line in the pool system. (Image 14) The amount of water flowing through the erosion feeder is controlled by a manual valve and determines the amount of chlorine concentration/residual added to the pool water. Manual adjustment of this valve does not allow the system to compensate for varying levels of contamination in the pool water.

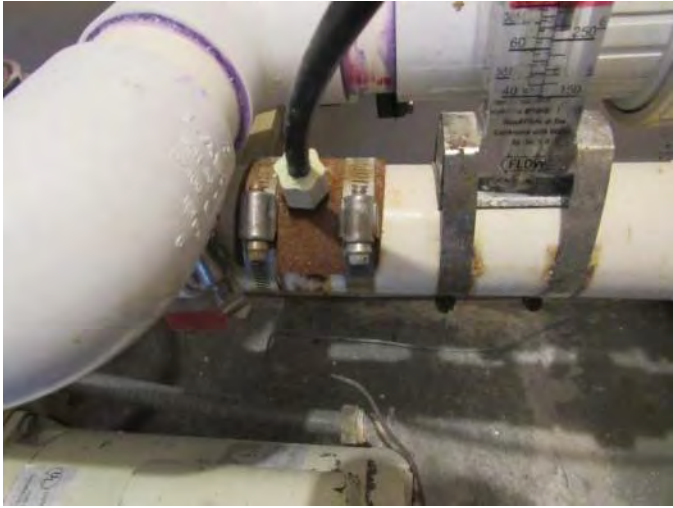
Image 17

- 3) Replace Corroded Brackets
  - The injection site of the chlorine erosion feeder is constructed with a metal plate and brackets. (Image 17) These metal components are badly corroded, likely because of contact with concentrated chlorine residual. These corroded pieces should be replaced with a PVC chemical injection fitting.

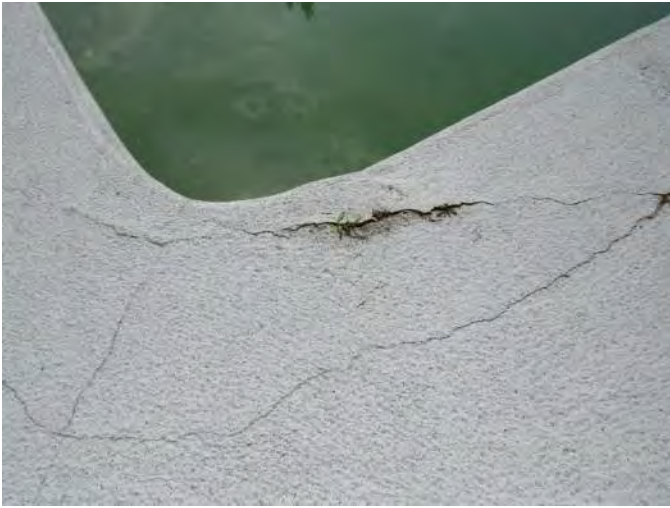
Image 19

Pool deck is chipping, cracking, and deteriorating (Image 19, 20, 22, 25)

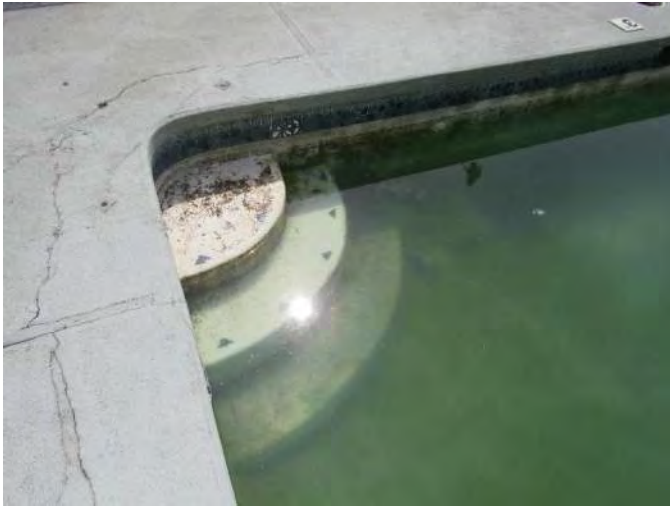
Image 22

Steps have periodically spaced “diamond” tile markers; unlikely to be considered sufficient markers of the edge of the step (Image 22)

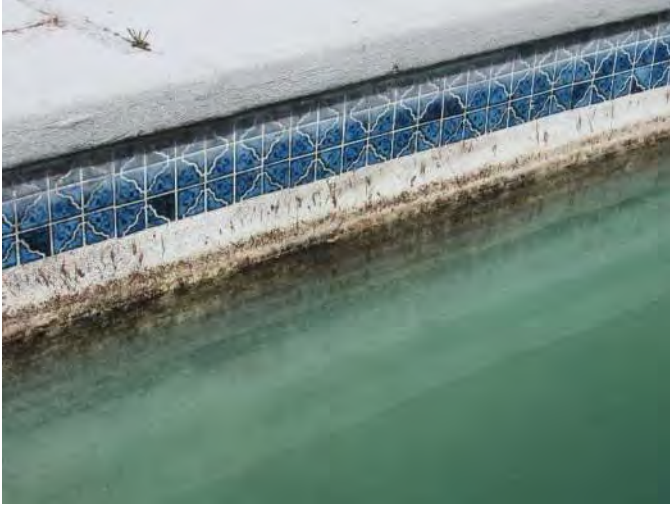
Image 23

Pool surface is badly deteriorated, cracking, and abrasive (Image 21, 23, 24)

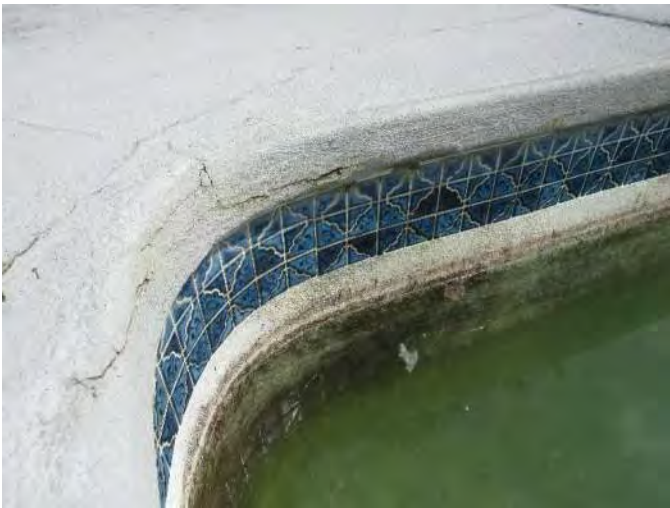
Image 24

Skimmer openings do not contain weirs (Image 24)

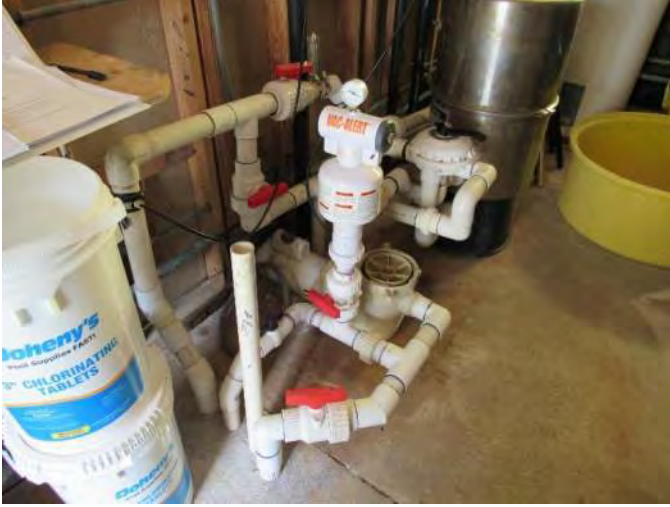
Image 29

- The current primary disinfection system mixes trichloroisocyanuric acid tablets (Trichlor) with pool water in an erosion feeder on a bypass line in the pool system. (Image 29) The amount of water flowing through the erosion is controlled by a manual valve and determines the amount of chlorine concentration/residual added to the pool water. Adjustment of this valve does not allow the system to compensate for varying levels of contamination in the pool water.

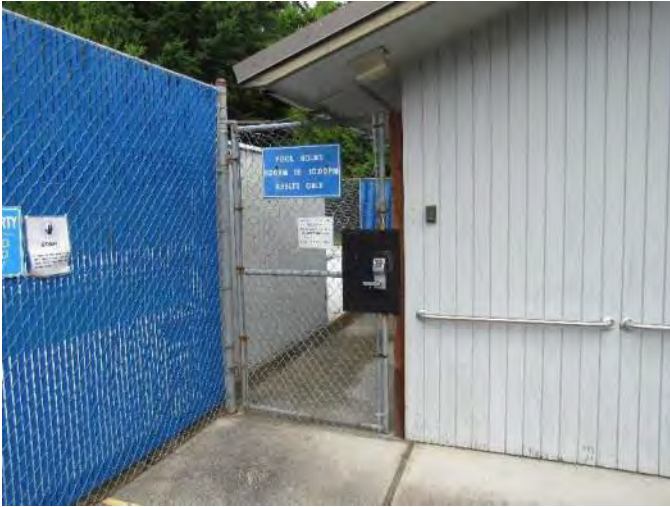
Image 32

Not stated in posted Pool Rules (Image 32)

Existing signage states “young children” leaving age undefined (Image 32)
